# Manhole Inspection Summary

Manhole # S45E2\_019MH

Insp Date: **12/31/07 11:03 AM**

**Location** Address: **3900 Pascal Ave**

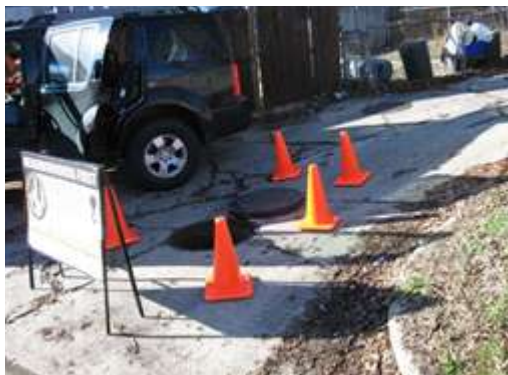
Location View

Inner Pascal

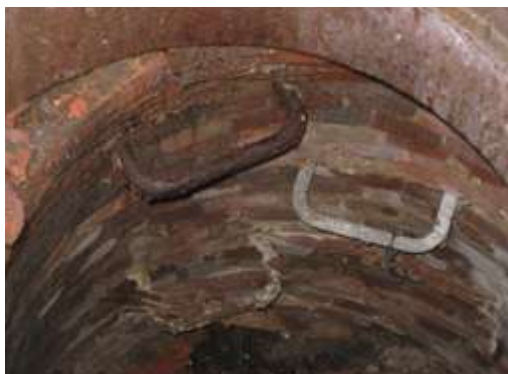
Steps

**Steps** Count: **3** Missing: **0** ☐ Corroded

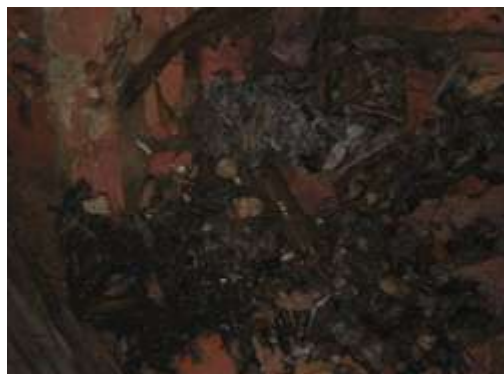
Defect 2

Debris

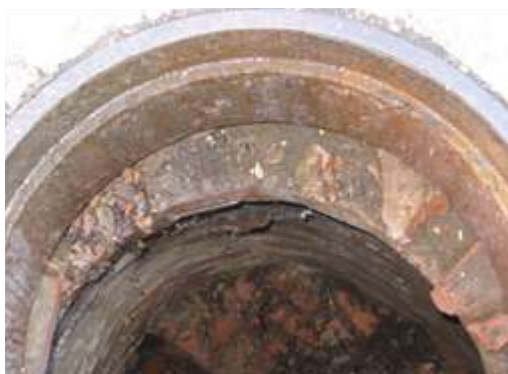
Defect 1

**Frame** Offset: **2.5** (in.) Condition: ☒ Sound ☐ Cracked ☐ Leaks

Frame offset

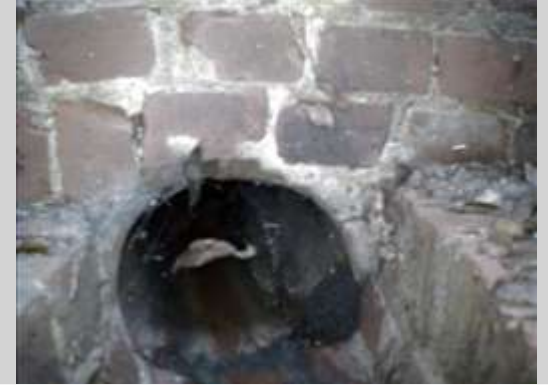
12 O'Clock Outflow

8 in. Circular Gravity Sewer  
Pipe Out @ 12 O'Clock

Pipe Height: **10.8** (in.) Rod and Bar (Angled)  
Pipe Material: **Clay** ☐ Pipe Lined  
Invert Depth: **7.45** (ft.) Flow Characteristics: **Fast**  
Deposits: ☒ None ☐ Mud ☐ Sludge ☐ **Debris** ☐ Grease  
Silt Depth: (in.) Deposits Extent:  
Infiltration: **None** Pipe Seal Cond: **Sound**

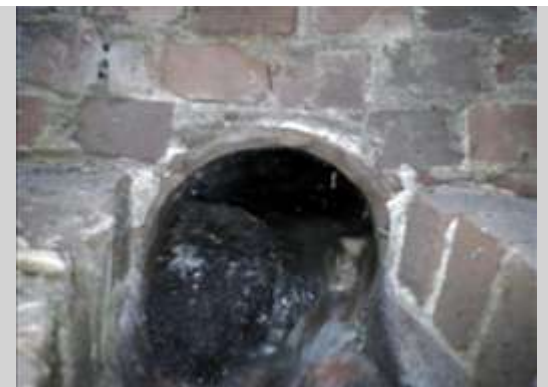
9 O'Clock Inflow

8 in. Circular Gravity Sewer  
Pipe In @ 9 O'Clock

Pipe Height: **8.4** (in.) Rod and Bar (Angled)  
Pipe Material: **Clay** ☐ Pipe Lined  
Invert Depth: **6.75** (ft.) Flow Characteristics: **Fast**  
Deposits: ☐ None ☐ Mud ☐ Sludge ☒ **Debris** ☐ Grease  
Silt Depth: **0** (in.) Deposits Extent: **Medium**  
Infiltration: **None** Pipe Seal Cond: **Sound**
